Inspection Report

Property Address:
2694 Hickory Valley Drive
Snellville, GA 30083

Date:
May 31, 2011

Inspector:
Charles Mann
Edifice Inspections, Inc.
(770) 594-2222

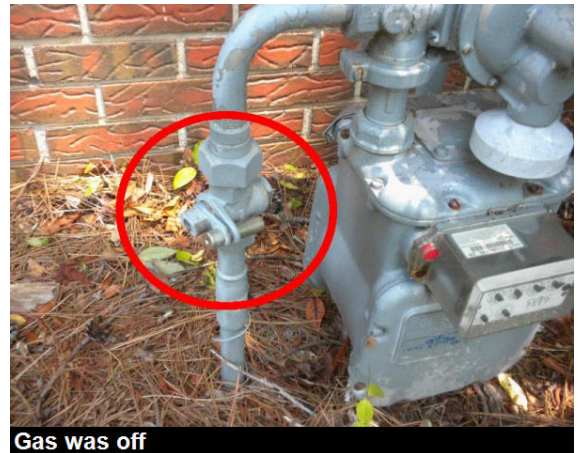
WATER SOURCE: Public.
SEWAGE DISPOSAL: Private.
UTILITIES STATUS: Gas service was off at time of inspection. The water heater and furnace could not be operated.

Gas was off

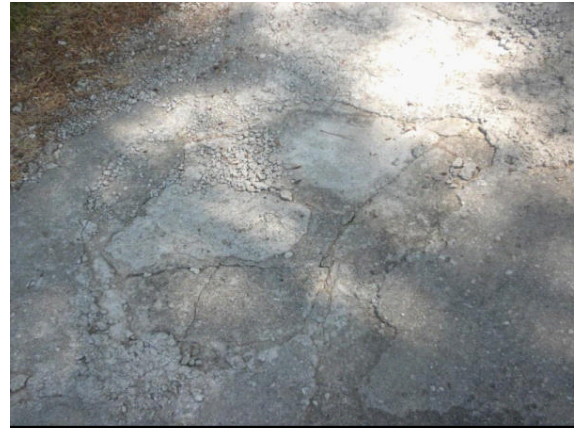
CONDITION: Cracking and displacement was noted from tree roots.

Cracking/displacement @ driveway

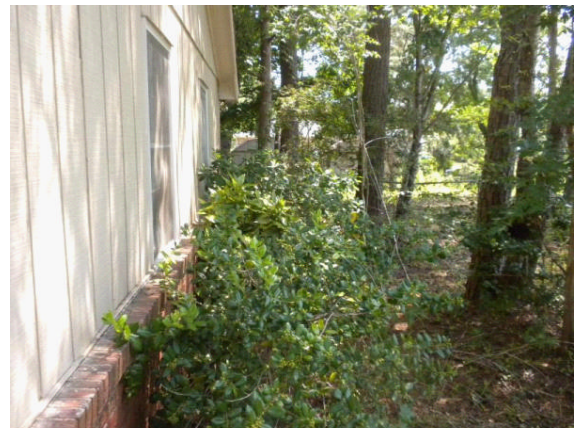
CONDITION: There are trees/bushes in contact with the house at the right side. Trimming of all trees/bushes away from the house is recommended to avoid damage to siding, trim or roofing.

Trim trees/bushes away from house

1. There are trees/bushes in contact with the house at the right side. Trimming of all trees/bushes away from the house is recommended to avoid damage to siding, trim or roofing.

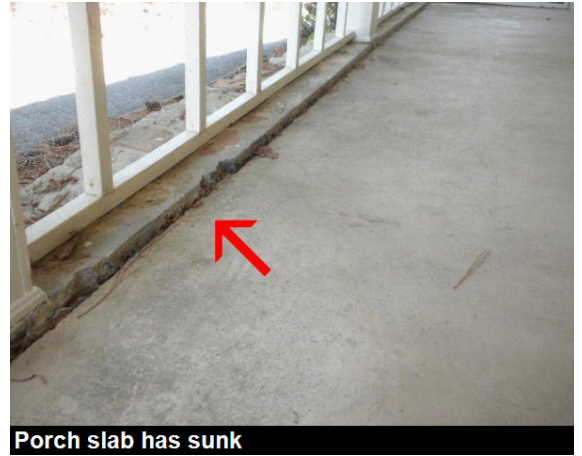
DESCRIPTION & CONDITION: The front entry porch slab has sunk. Some additional movement can be expected over time. Repairs can be made by a qualified contractor.

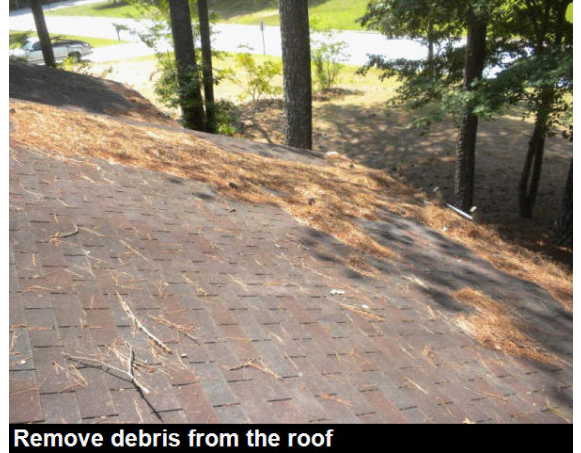
STYLE & PITCH:	Gable.
ROOFING TYPE:	Asphalt composition shingles.
ROOF ACCESS:	Walked on roof.
ROOF COVERING CONDITION:	The roof is covered with pine straw. Removing all debris from the roof is recommended. General condition appears serviceable with signs of weathering/curling and aging. Regular maintenance and inspections are advised. Expected 4 to 5 years of life from the roof.

Remove debris from the roof

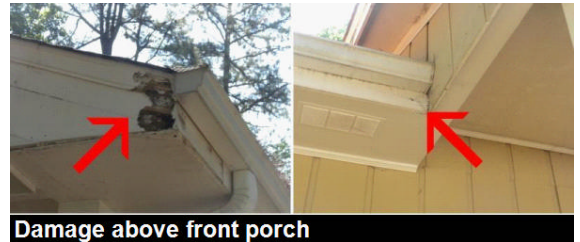
CONDITION: Loose or deteriorated material was noted in the following location(s): above the front left corner of the front porch. Recommend repairs be made by a qualified general contractor.

Damage above front porch

1. Loose or deteriorated material was noted in the following location(s): above the front left corner of the front porch. Recommend repairs be made by a qualified general contractor.

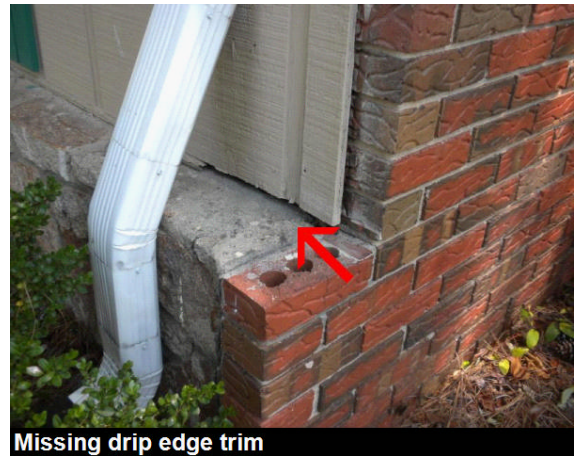
CONDITION: Damaged/missing drip edge trim was noted at the front right corner of the house. Condition(s) should be repaired/replaced as necessary by a qualified general contractor.

Missing drip edge trim

2. Damaged/missing drip edge trim was noted at the front right corner of the house. Condition(s) should be repaired/replaced as necessary by a qualified general contractor.

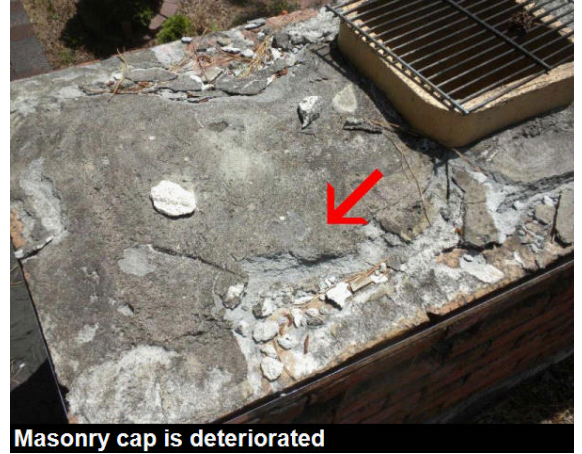
The masonry chimney cap is deteriorated. Recommend installing a metal chimney cap. Repairs can be made by a qualified chimney sweep.

Masonry cap is deteriorated

4. The masonry chimney cap is deteriorated. Recommend installing a metal chimney cap. Repairs can be made by a qualified chimney sweep.

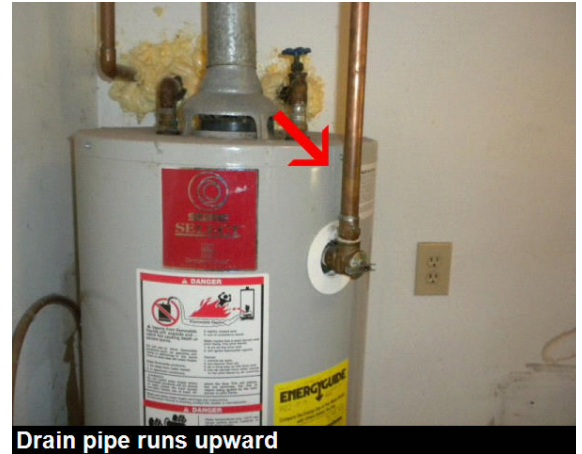
The unit could not be operated. The gas was off. **The pipe on the temperature pressure relief valve discharges in an upward direction. The valve manufacturer requires that the valve discharge downward or be able to be drained after the valve is tested.** Repairs should be made by a qualified, licensed plumber.

8. The pipe on the temperature pressure relief valve discharges in an upward direction. The valve manufacturer requires that the valve discharge downward or be able to be drained after the valve is tested.

Repairs should be made by a qualified, licensed plumber.

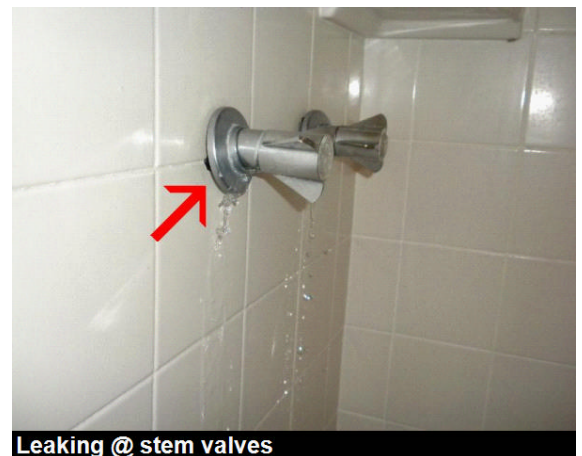
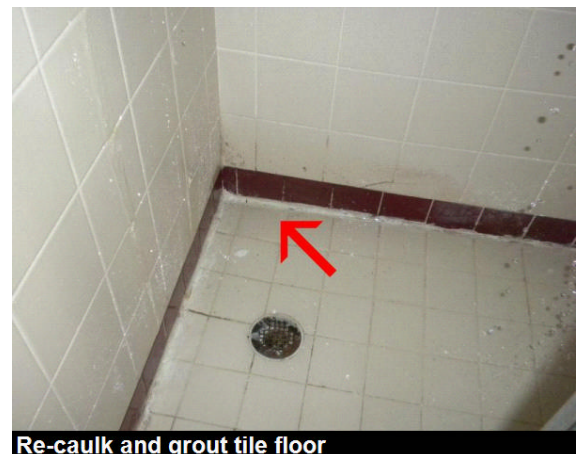
Leaking was noted from the shower stem valves. Re-caulking and grouting the tile floor in the shower is recommended. Conditions should be further evaluated and repaired as necessary by a qualified, licensed plumber.

9. Leaking was noted from the shower stem valves.

Re-caulking and grouting the tile floor in the shower is recommended.

Conditions should be further evaluated and repaired as necessary by a qualified, licensed plumber.

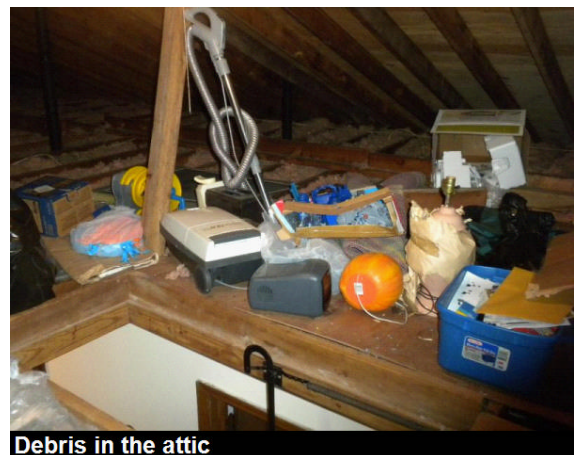
Some debris, boxes and old lamps were in the attic.

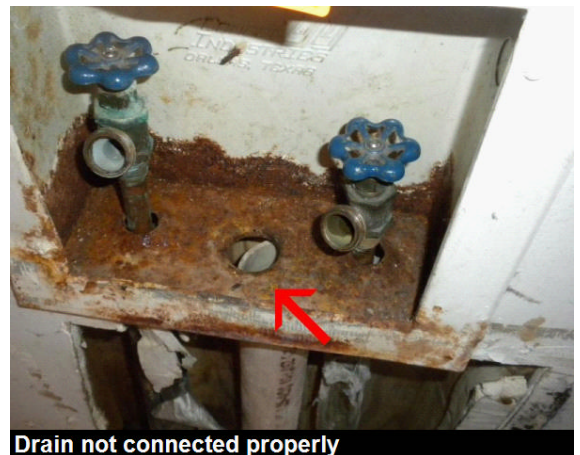
CONDITION: The washing machine drain pipe is not properly connected to the plumbing box. Further evaluation and repairs will be needed by a qualified, licensed plumber.

12. The washing machine drain pipe is not properly connected to the plumbing box. Further evaluation and repairs will be needed by a qualified, licensed plumber.

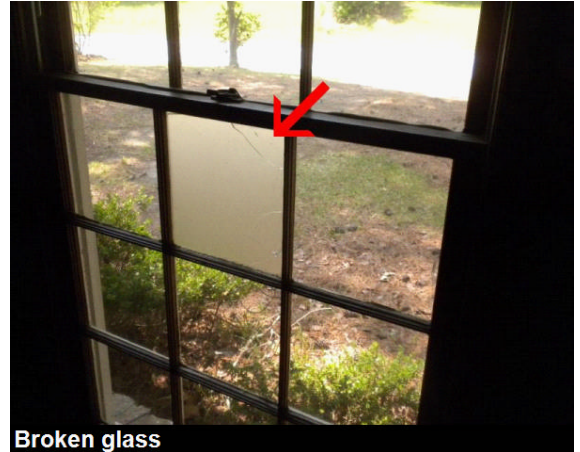
TYPE & CONDITION: Wood, Broken/cracked glass panes were noted in the following locations: front left bedroom window. Repairs should be made by a qualified contractor.

Broken glass

5. Broken/cracked glass panes were noted in the following locations: front left bedroom window. Repairs should be made by a qualified contractor.

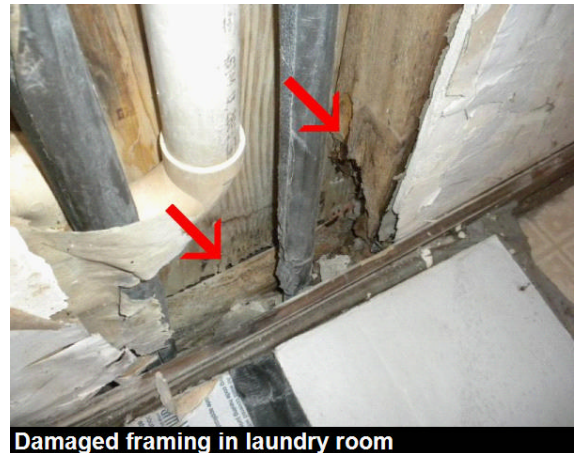
MATERIAL & CONDITION: Drywall. Damage was noted to the drywall and framing in the laundry room under the washing machine plumbing connections. Repairs can be made by a qualified contractor.

Damaged framing in laundry room

13. Damage was noted to the drywall and framing in the laundry room under the washing machine plumbing connections.

Repairs can be made by a qualified contractor.
