Inspection Report

Property Address:
1707 Summit Creek Way
Loganville, GA 30052

Date:
February 22, 2012

Inspector:
Charles Mann
Edifice Inspections, Inc.
(770) 594-2222

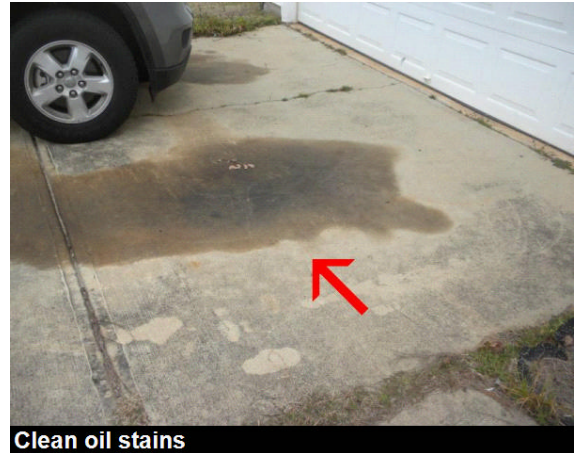
CONDITION: Oil stains were noted on the driveway. Pressure washing and cleaning the driveway is recommended.

Clean oil stains

1. Oil stains were noted on the driveway. Pressure washing and cleaning the driveway is recommended.

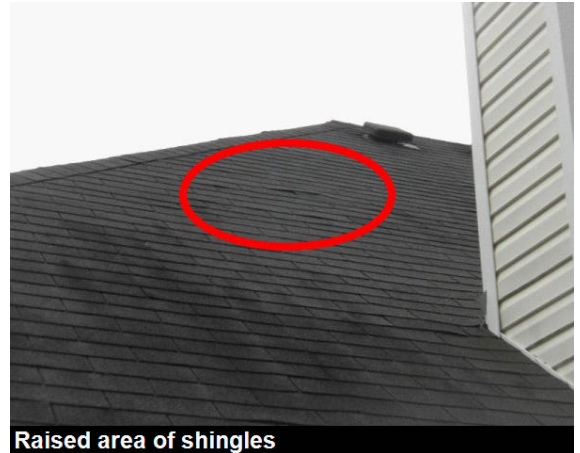
STYLE & PITCH:	Gable. High.
ROOFING TYPE:	Asphalt composition shingles.
ROOF ACCESS:	Visually from ground.
ROOF COVERING CONDITION:	A raised area of shingles was noted at the rear of the house near the chimney. Condition(s) should be repaired as necessary by a qualified roofing contractor.

Raised area of shingles

2. A raised area of shingles was noted at the rear of the house near the chimney. Condition(s) should be repaired as necessary by a qualified roofing contractor.

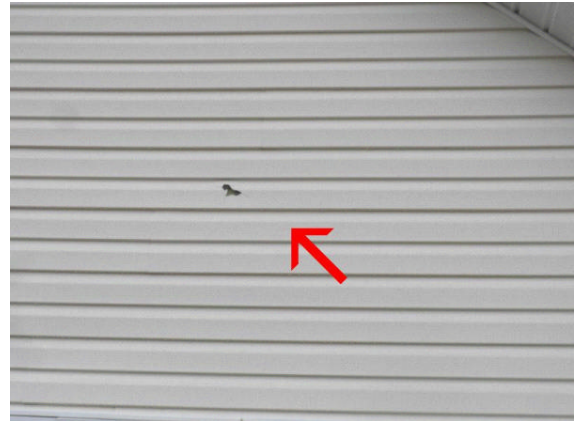
Damaged siding was noted in the following location(s):
above the garage door.
Replacing the damaged piece of siding is recommended.
Mildew growth was noted on the siding. Pressure washing the siding is recommended.

Damaged siding above the garage

3. Damaged siding was noted in the following location(s): above the garage door. Replacing the damaged piece of siding is recommended.

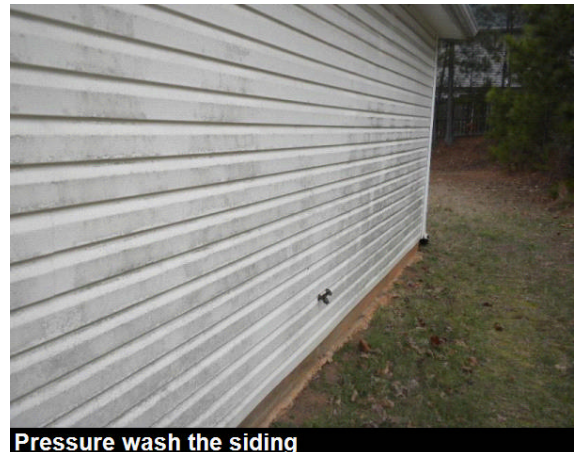
Pressure wash the siding

Mildew growth was noted on the siding. Pressure washing the siding is recommended.

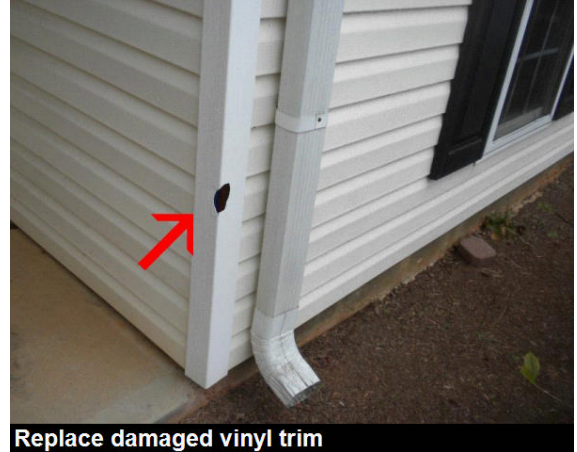
Damage noted in the following location(s): vinyl trim near the front entry door. Condition(s) should be repaired/replaced as necessary by a qualified general contractor.

4. Damage noted in the following location(s): vinyl trim near the front entry door. Condition(s) should be repaired/replaced as necessary by a qualified general contractor.

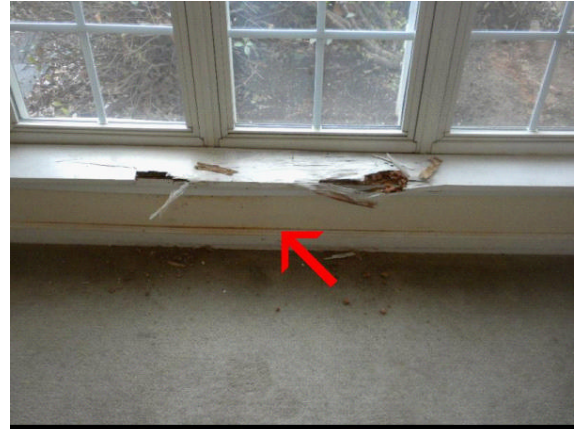
An active infestation by wood destroying insects was observed in the following location(s): under the dining room windows, at the rear kitchen bay. Further evaluation and treatment is recommended by a qualified pest control contractor. Repairs to the trim and framing are recommended by a qualified contractor.

Damage @ dining room window

Further evaluation and treatment is recommended by a qualified pest control contractor.

Repairs to the trim and framing are recommended by a qualified contractor.

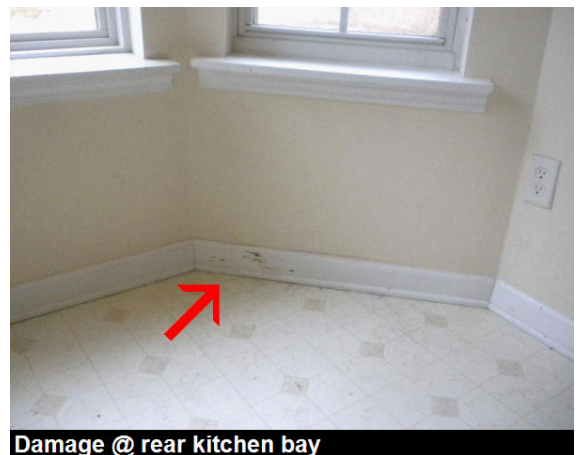
Damage @ rear kitchen bay

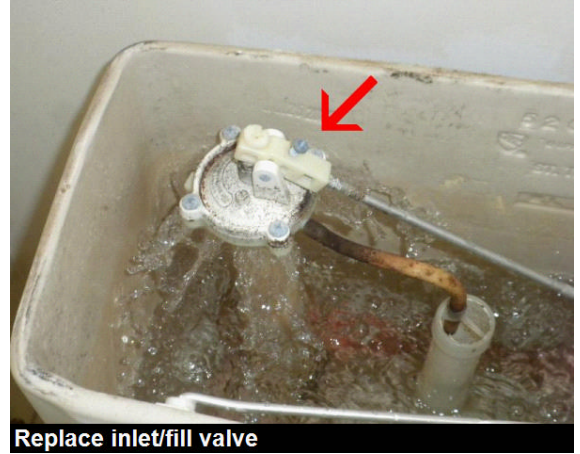
Commode(s) run continuously in the following locations: Hall bathroom.
The inlet/fill valve at the master bathroom commode is leaking and should be replaced.
Condition(s) should be repaired by a qualified, licensed plumber.

5. Commode(s) run continuously in the following locations: Hall bathroom.
The inlet/fill valve at the master bathroom commode is leaking and should be replaced.
Condition(s) should be repaired by a qualified, licensed plumber.

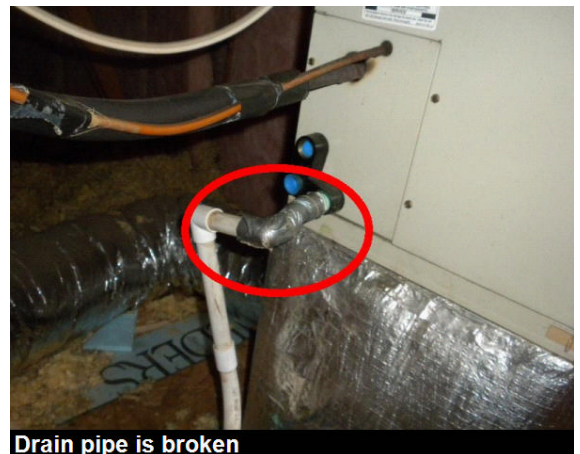
SYSTEM TYPE: Central.
POWER SOURCE: Electric, 240 Volt.
CONDENSATE LINES: The condensation drain pipe is broken in the attic near the air handler. This condition has caused the ceiling stains in the kitchen. Repairs should be made by a qualified, licensed HVAC contractor.

Drain pipe is broken

Repairs should be made by a qualified, licensed HVAC contractor.

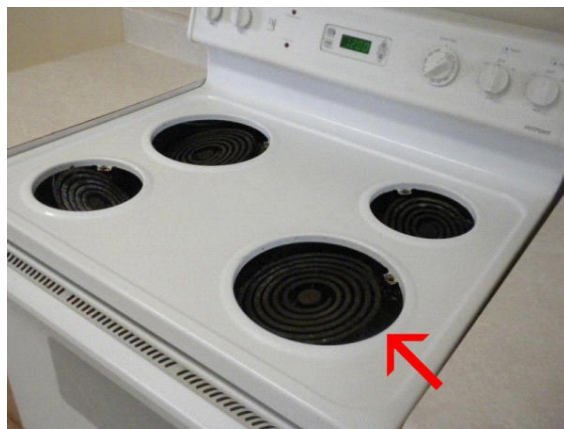
TYPE/CONDITION: Electric. The burner pans are missing and should be replaced.

Replace burner pans

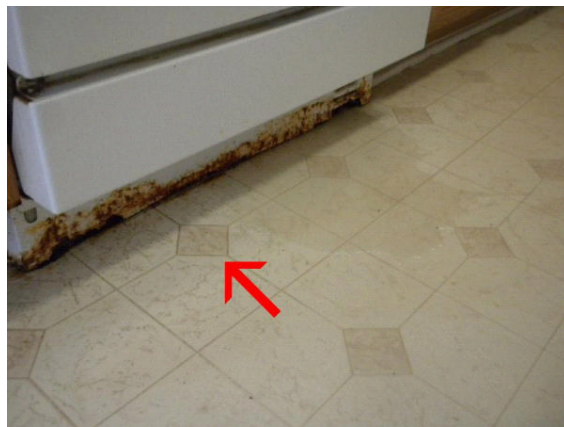
CONDITION: The dishwasher is leaking during operation. Repairs should be made by a qualified contractor.

Dishwasher is leaking

6. The dishwasher is leaking during operation. Repairs should be made by a qualified contractor.

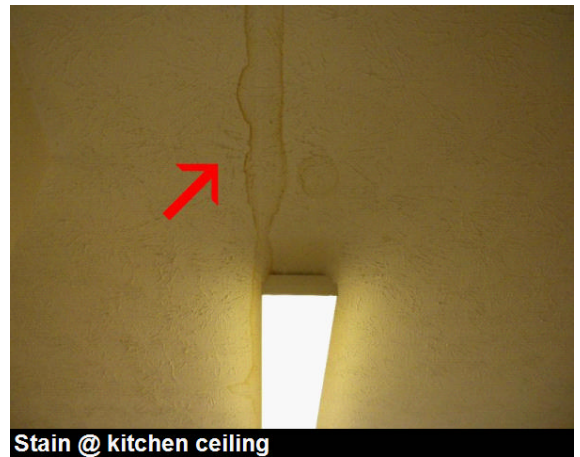
Drywall, Moisture staining noted in the following locations: kitchen. See the HVAC section for more information.
