## Inspection Report

**Property Address:**  
3412 Summit Creek Lane  
Loganville, GA 30052

**Date:**  
June 08, 2012

**Inspector:**  
Charles Mann  
Edifice Inspections, Inc.  
(770) 594-2222  
[www.edificeinspections.com](http://www.edificeinspections.com)

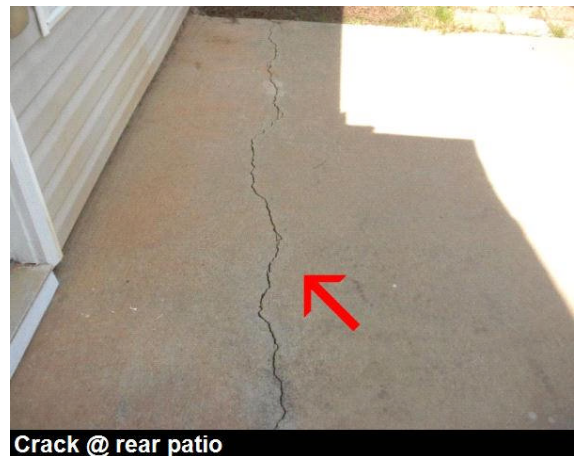
**TYPE:** Concrete.  
**CONDITION:** A crack was noted in the patio near the house. No problems were noted as a result of this condition. Some additional cracking may occur.

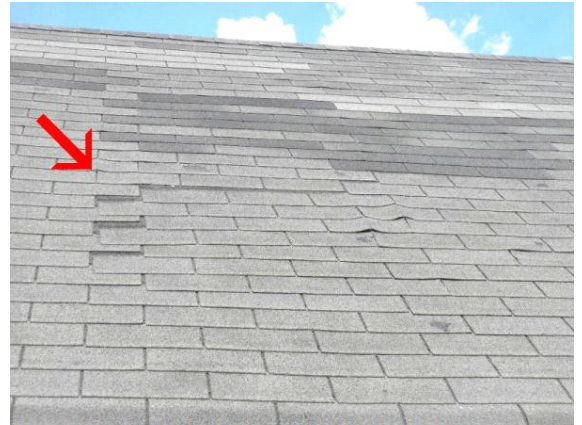
<b>STYLE &amp; PITCH:</b>	Combination Gable/Hip, High.
<b>ROOFING TYPE:</b>	Asphalt composition shingles.
<b>ROOF ACCESS:</b>	Visually from ground.
<b>ROOF COVERING CONDITION:</b>	<p>Previous repairs and loose shingles were noted at the right side of the house. Additional repairs are needed. All loose shingles should be removed and new shingles installed. A torn/damaged shingle was noted near the ridge above the front entry door. Replacing the affected shingles is recommended.</p> <p>Condition(s) should be further evaluated and repaired as necessary by a qualified roofing contractor.</p>

Loose shingles @ right side of the house

1. Previous repairs and loose shingles were noted at the right side of the house. Additional repairs are needed. All loose shingles should be removed and new shingles installed.

Condition(s) should be further evaluated and repaired as necessary by a qualified roofing contractor.

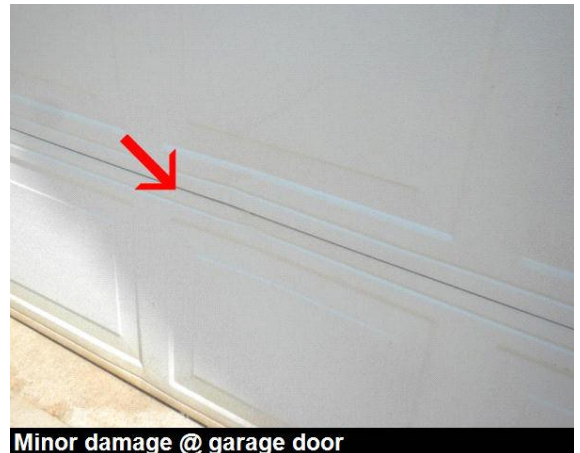
Minor damage was noted to the bottom panel of the garage door. This damage does not affect the operation of the door.

Minor damage @ garage door

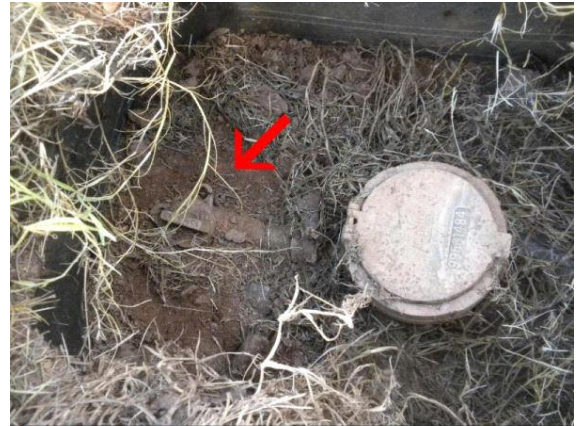
**CONDITION:** Acceptable. The water meter was on at the time of the inspection.

Water meter was on

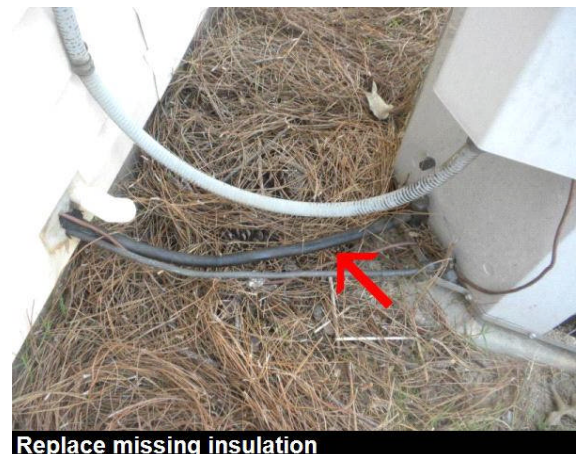
**SYSTEM TYPE:** Central.  
**POWER SOURCE:** Electric, 240 Volt.  
**CONDENSATE LINES:** Condensate line installed.  
**NORMAL CONTROLS:** Acceptable.  
**MANUFACTURER:** Carrier.  
**APPROXIMATE AGE IN YEARS:** 13.  
**APPROX. CAPACITY IN TONS:** 2 1/2.  
**CONDITION:** The insulation on the large refrigerant line between the compressor and the exterior wall is worn/missing and should be replaced.  
Expect replacement of the A/C unit in the next 2 to 3 years.

1. The insulation on the large refrigerant line between the compressor and the exterior wall is worn/missing and should be replaced.
