Inspection Report

Property Address:
545 Briar Run Court
Loganville, GA 30052

Date:
July 17, 2011

Inspector:
Charles Mann
Edifice Inspections, Inc.
(770) 594-2222

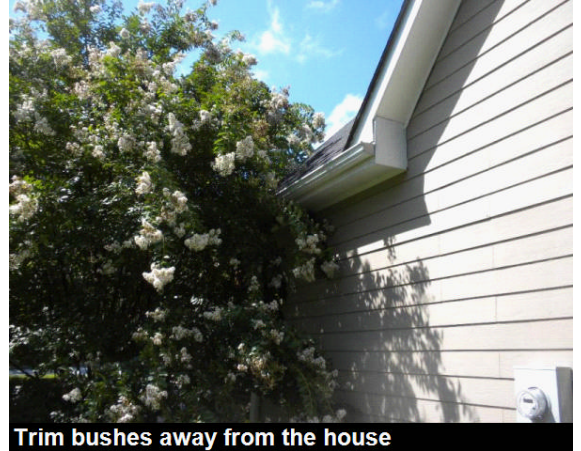
CONDITION: There are trees/bushes in contact with the house. Trimming of all trees/bushes away from the house is recommended to avoid damage to siding, trim or roofing.

Trim bushes away from the house

1. There are trees/bushes in contact with the house. Trimming of all trees/bushes away from the house is recommended to avoid damage to siding, trim or roofing.

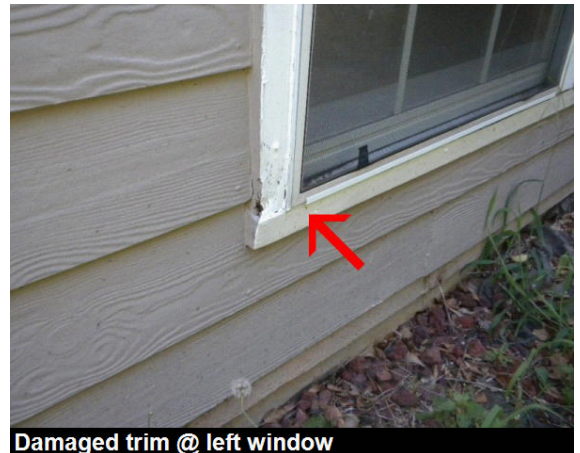
CONDITION: Damage noted in the following location(s): rear vertical trim boards on the chimney, window trim at the left side rear window. Condition(s) should be repaired/replaced as necessary by a qualified general contractor.

Damaged trim @ left window

Condition(s) should be repaired/replaced as necessary by a qualified general contractor.

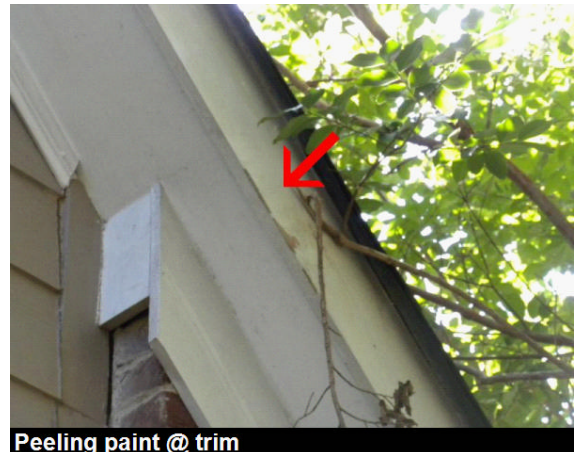
Peeling paint observed at the fascia, soffits and trims. Repainting the exterior trim is needed. The siding can also be repainted but the siding paint is not in as bad of shape as the trim.

Peeling paint @ trim

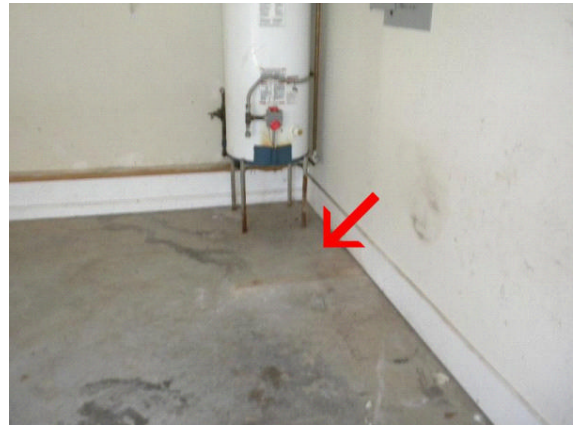
The barrier in front of the water heater has been removed. A post or barrier should be installed to prevent a vehicle from damaging the water heater.

Install barrier in front of water heater

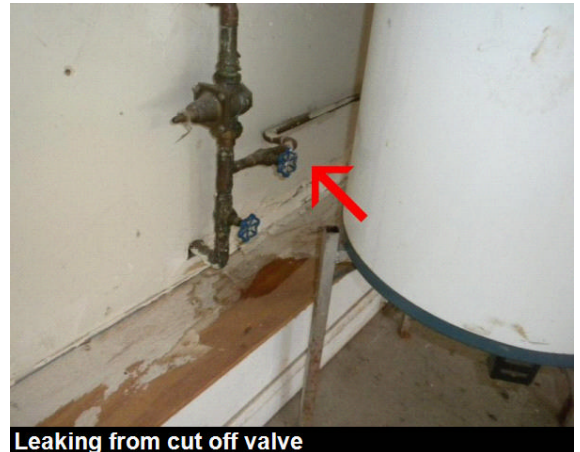
OPERATION: Leaking was noted from the hose faucet cut off valve near the water heater. Recommend further evaluation and repairs by a qualified, licensed plumber.

Leaking from cut off valve

Recommend further evaluation and repairs by a qualified, licensed plumber.

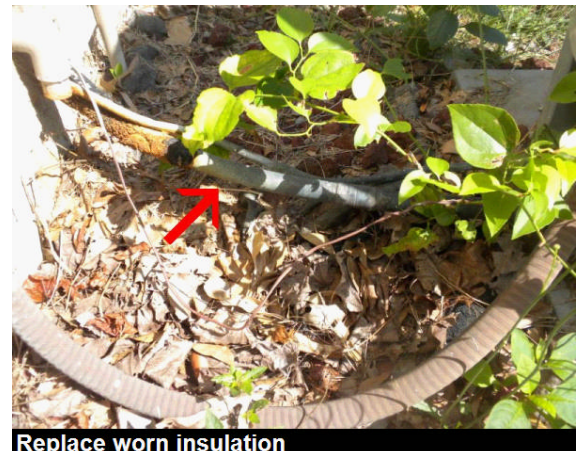
SYSTEM TYPE: Central.
POWER SOURCE: Electric, 240 Volt.
CONDENSATE LINES: Condensate line installed.
NORMAL CONTROLS: Acceptable.
MANUFACTURER: Comfortmaker.
APPROXIMATE AGE IN YEARS: 14.
APPROX. CAPACITY IN TONS: 3 1/2.
CONDITION: The insulation on the large refrigerant line between the compressor and the exterior wall and in several places in the attic is worn/missing and should be replaced. Rusting was noted inside the furnace as a result of prolonged exposure to condensation. The condensing unit is near the end of its life expectancy. Replacement should be budgeted for. These units have an average life expectancy of 15 years.

Replace worn insulation

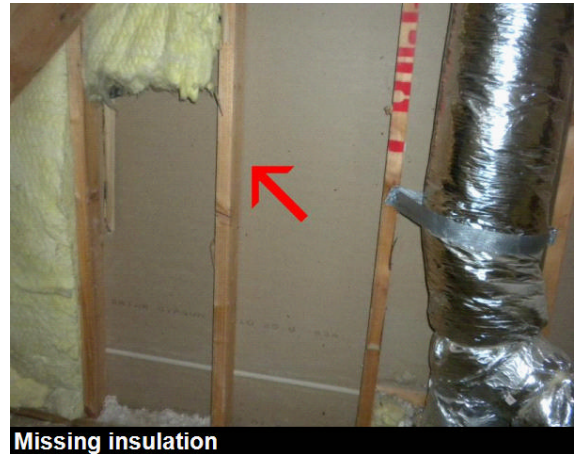
TYPE: Fiberglass loose fill, Fiberglass batts.
APPROXIMATE DEPTH IN INCHES: 5 to 10.
CONDITION: Insulation is missing in the following areas: knee wall space at the front right bedroom area. Replacing the missing insulation is recommended.

Missing insulation

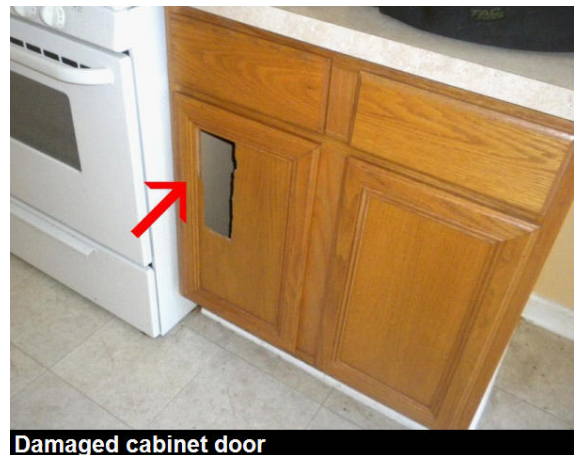
TYPE AND CONDITION: Wood. A damaged cabinet door was noted next to the range.

Damaged cabinet door
