Inspection Report

Property Address:
56 Riverview Place
Douglasville, GA 30134

Date:
September 19, 2012

Inspector:
Charles Mann
Edifice Inspections, Inc.
(770) 594-2222
www.edificeinspections.com

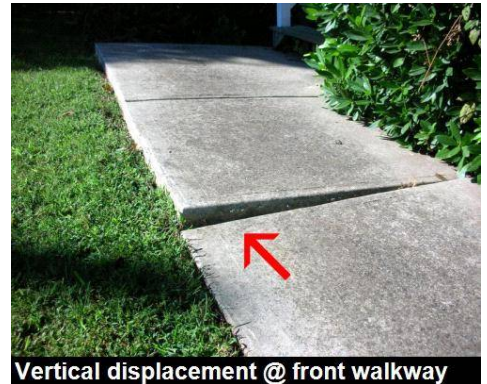
Type: Concrete.
Condition: Cracking and vertical displacement were noted. Repairs can be made by a qualified contractor.

Vertical displacement @ front walkway

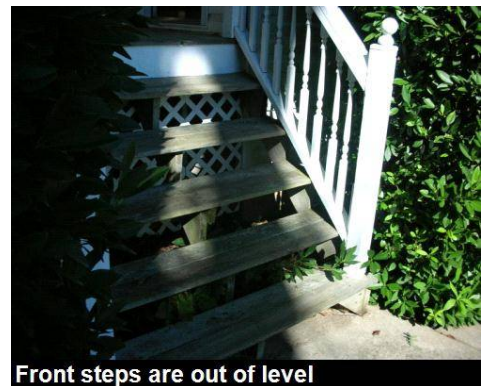
Description: Wood.
Condition: The front wooden steps are out of level. Installing additional concrete under the bottom of the stair stringers is recommended to re-level the stairs. Recommend repairs be made by a licensed general contractor.

Front steps are out of level

2. The front wooden steps are out of level. Installing additional concrete under the bottom of the stair stringers is recommended to re-level the stairs.
Recommend repairs be made by a licensed general contractor.

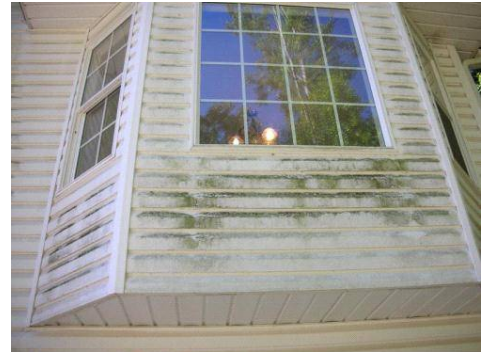
Condition: Cleaning and/or pressure washing the vinyl is recommended.

Clean mildew from vinyl

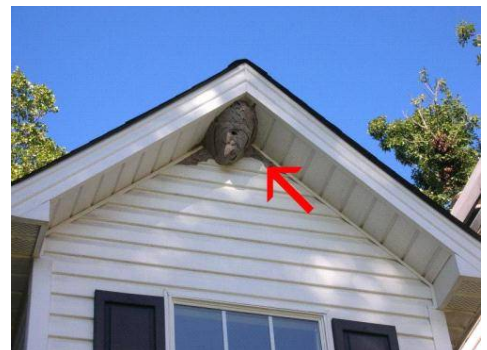
A large hornet or wasp nest was noted at the front gable. Removing this nest is recommended.

Remove nest

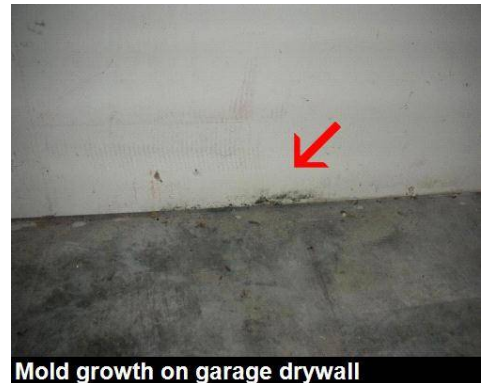
Accessibility:	Fully accessible.
Visible Foundation Walls:	Concrete block.
Foundation Condition:	Acceptable.
Basement Floor:	Concrete.
Basement Floor Condition:	Typical cracking noted.
Floor Structure:	Conventional wood joists.
Floor Structure Condition:	Acceptable, Areas of the floor structure hidden behind finished floors and ceilings could not be observed.
Columns/Piers:	Steel.
Column/Pier Condition:	Acceptable.
Water Penetration:	Suspected mold/mildew was observed in the following locations: drywall near the water heater. See www.epa.gov/mold for more information. Repairs can be made by a qualified contractor.

Mold growth on garage drywall

3. Suspected mold/mildew was observed in the following locations: drywall near the water heater. See www.epa.gov/mold for more information.
Repairs can be made by a qualified contractor.

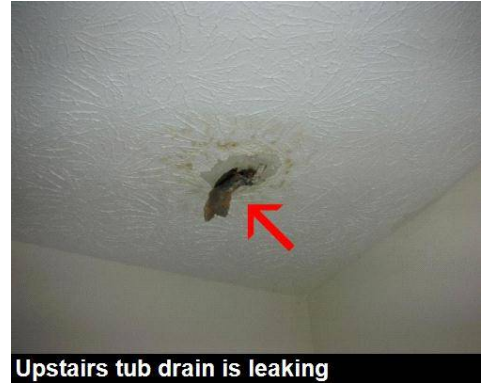
BATHTUBS: The upstairs bathroom tub drain is leaking (visible from master bathroom closet).
Condition(s) should be repaired by a qualified, licensed plumber.

Upstairs tub drain is leaking

5. The upstairs bathroom tub drain is leaking (visible from master bathroom closet).
Condition(s) should be repaired by a qualified, licensed plumber.

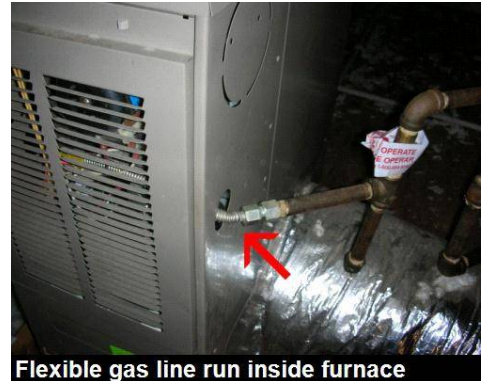
FUEL TYPE & CONDITION: Natural Gas, **Improper flexible gas connectors have been used inside the furnace. A solid pipe should be run to the outside of the furnace where a flexible gas connector can be used. Repairs should be made by a qualified, licensed HVAC contractor.**

Flexible gas line run inside furnace

6. Improper flexible gas connectors have been used inside the furnace. A solid pipe should be run to the outside of the furnace where a flexible gas connector can be used. Repairs should be made by a qualified, licensed HVAC contractor.

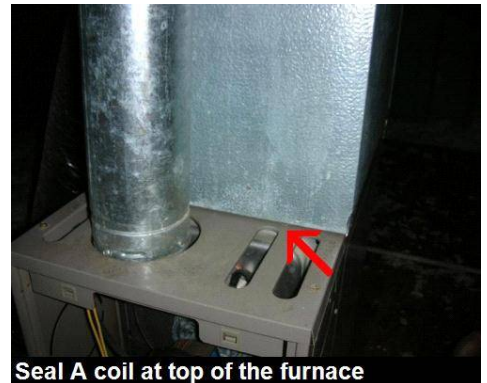
DISTRIBUTION TYPE AND CONDITION: Forced Air. **The A coil is not properly sealed at the top of the furnace. Conditioned air is leaking into the attic. Repairs should be made by a qualified, licensed HVAC contractor.**

Seal A coil at top of the furnace

7. The A coil is not properly sealed at the top of the furnace. Conditioned air is leaking into the attic. Repairs should be made by a qualified, licensed HVAC contractor.

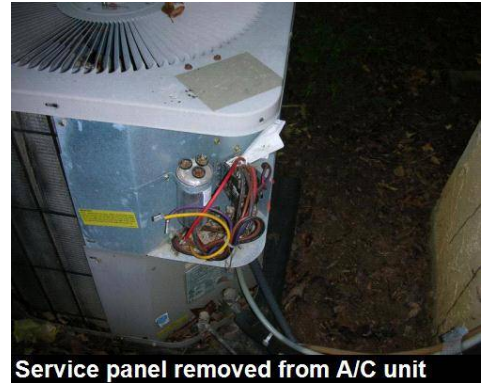
The A/C did not operate (2nd floor unit). The service panel has been removed from the A/C unit indicating that it has been previously worked on. Further evaluation and repair or replacement by a qualified HVAC contractor is recommended.

Service panel removed from A/C unit

8. The A/C did not operate (2nd floor unit). The service panel has been removed from the A/C unit indicating that it has been previously worked on.

Further evaluation and repair or replacement by a qualified HVAC contractor is recommended.

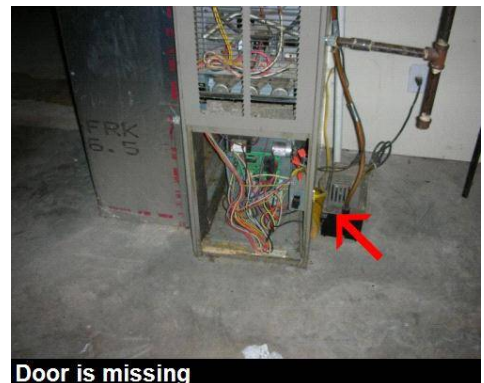
CONDITION: The unit did not operate. The blower compartment door is missing. The unit will not operate without this door in place. Contact a qualified, licensed heating contractor for further evaluation and repairs as needed.

Door is missing

10. The unit did not operate. The blower compartment door is missing. The unit will not operate without this door in place. Contact a qualified, licensed heating contractor for further evaluation and repairs as needed.

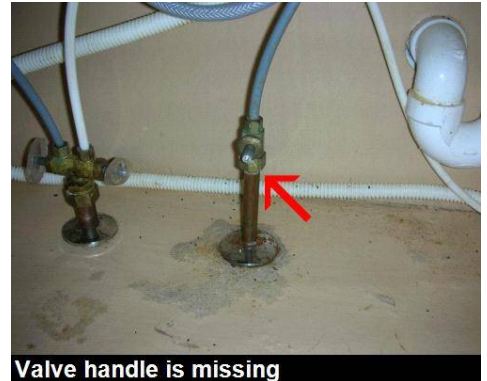
CONDITION: The cold water cut off valve handle is missing under the kitchen sink. A qualified, licensed plumber should be called to make further evaluation and repairs as needed.

2. The cold water cut off valve handle is missing under the kitchen sink. A qualified, licensed plumber should be called to make further evaluation and repairs as needed.

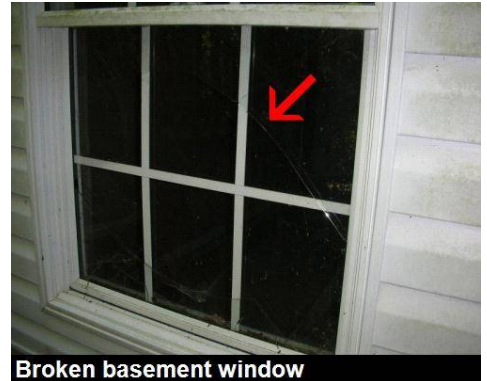
Condition: Broken/cracked glass panes were noted in the following locations: rear left basement window. Repairs should be made by a qualified contractor.

Broken basement window

4. Broken/cracked glass panes were noted in the following locations: rear left basement window.
Repairs should be made by a qualified contractor.

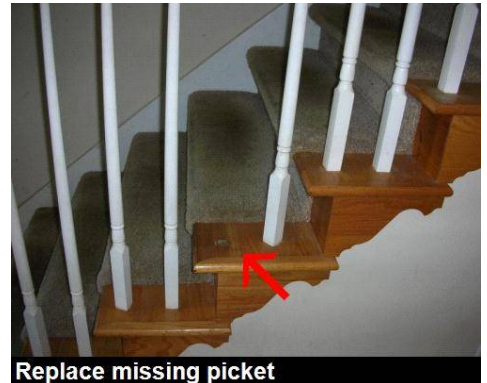
Condition: One of the pickets is missing from the stairs to the 2nd floor. Repairs can be made by a qualified contractor.

Replace missing picket

5. One of the pickets is missing from the stairs to the 2nd floor. Repairs can be made by a qualified contractor.

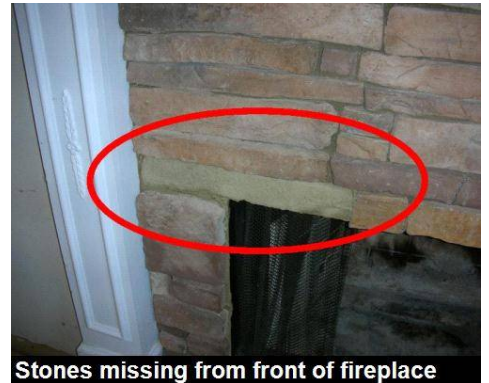
Some of the stones are missing from the front of the fireplace. Repairs can be made by a qualified contractor.

Stones missing from front of fireplace

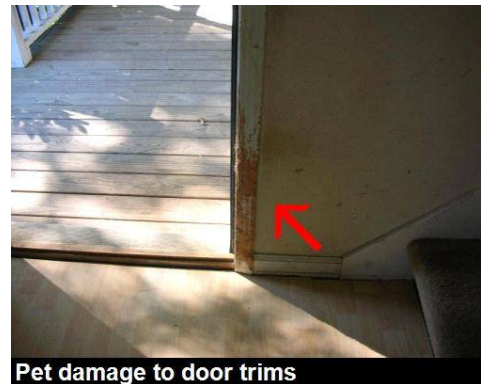
Door trims are damaged at the 1st and 2nd floor from pets.

Pet damage to door trims
