Inspection Report

Property Address:
1884 Valley View Rd.
Snellville, GA 30078

Date:
November 20, 2012

Inspector:
Bill Garwood
Edifice Inspections, Inc.
(770) 594-2222
www.edificeinspections.com

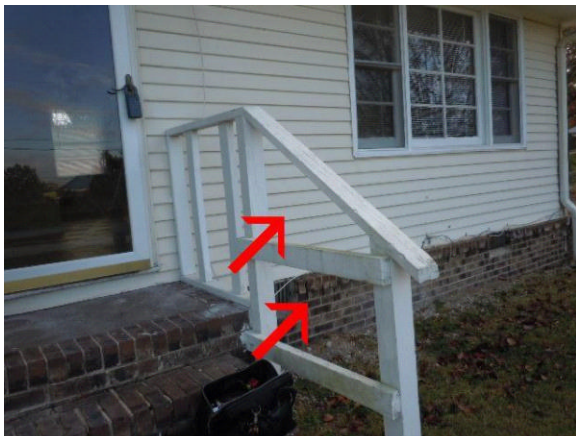
Wide rail spaces.

The spacing of the guardrails are wider than allowable by contemporary standards. Recommend repairs be made by a licensed general contractor for safety.

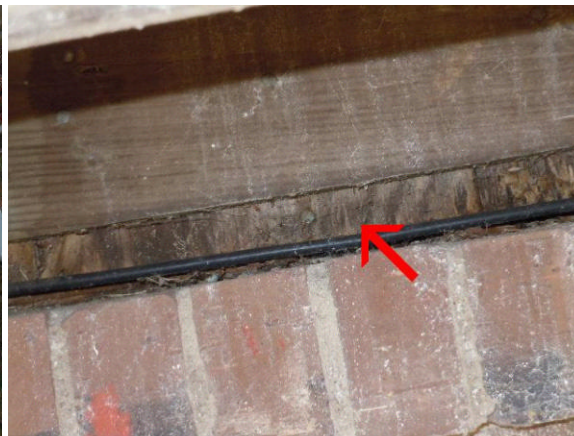
Decayed siding under stoop

The right side wood stoop is not flashed at its connection to the house. This condition has resulted in decay of the original wood siding under the stoop. The decayed siding should be replaced and the stoop flashed by a licensed general contractor.

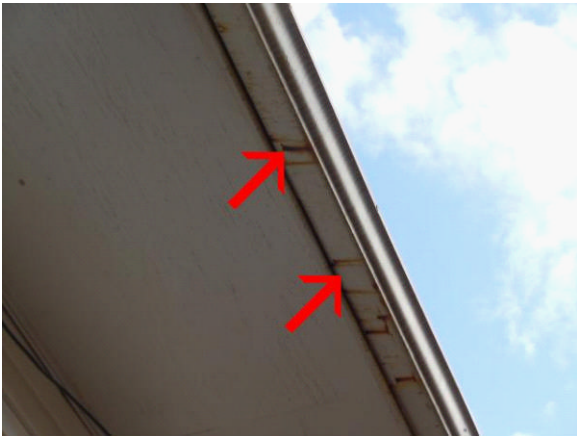
Rusted gutter

The gutter on the front of the right side of the upper roof has pulled loose from the house, is holding water and has rusted out on the bottom. This section of gutter should be replaced. Repairs should be made by a qualified contractor.

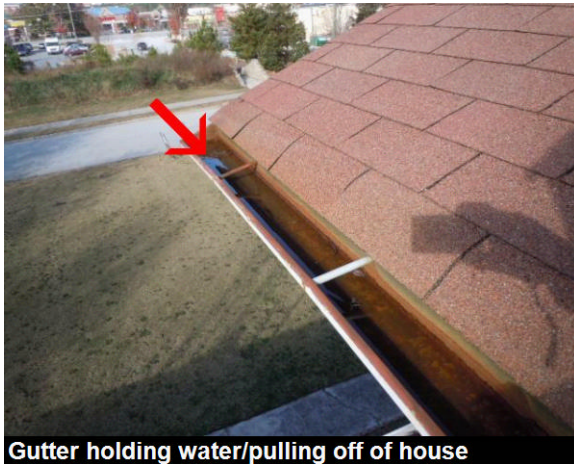
Gutter holding water/pulling off of house

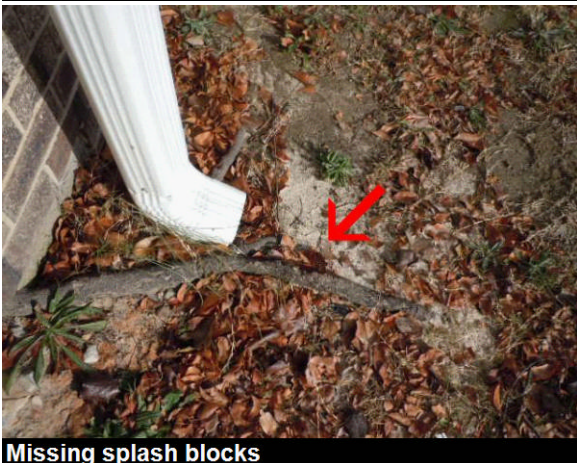
Missing splash blocks

Splash blocks were missing/not installed. Installation of splash blocks is recommended.

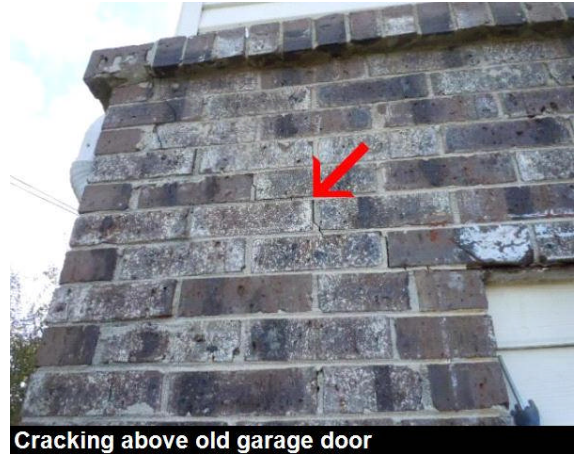
Some minor brick cracking was noted above the left upper corner of the garage door, under the front double windows and in the middle of the rear of the house. Periodic monitoring for additional movement is recommended.

Cracking above old garage door

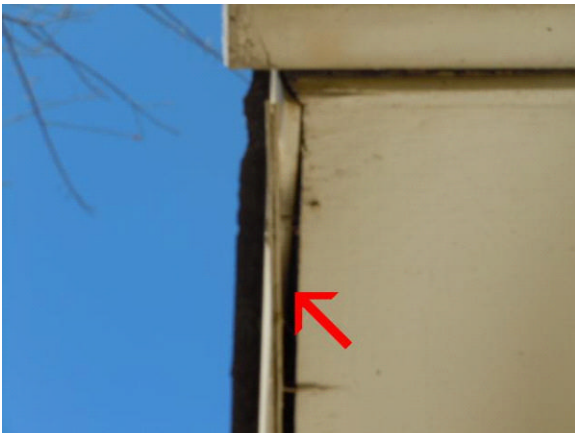
The corners of the fascia are loose and/or decayed at the right front corner of both the lower and upper roofs and the left rear corner of the upper roof.

Fascia pulling loose

Recommend repairs be made by a licensed general contractor.

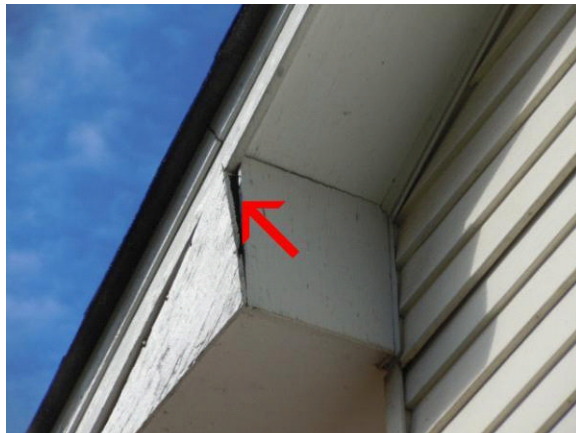
Fascia pulling loose

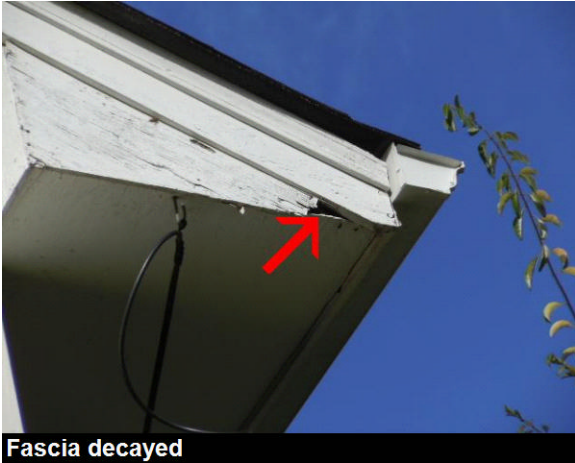
Fascia decayed

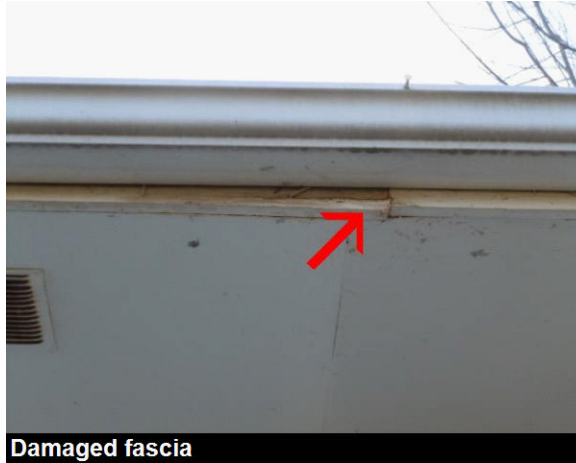
There is a cracked piece of fascia at the right front of the house.

Damaged fascia

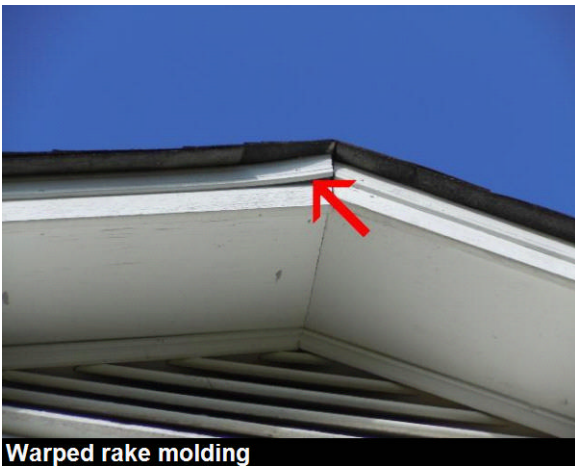
Warped rake molding

A piece of rake molding has warped at the rear upper gable.

Conditions should be repaired/replaced as necessary by a licensed general contractor.

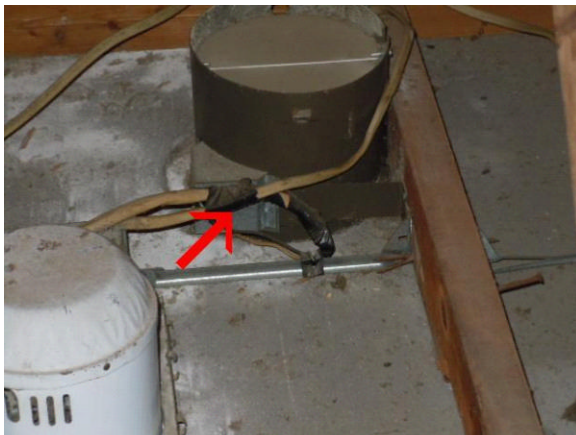
Open wire splices

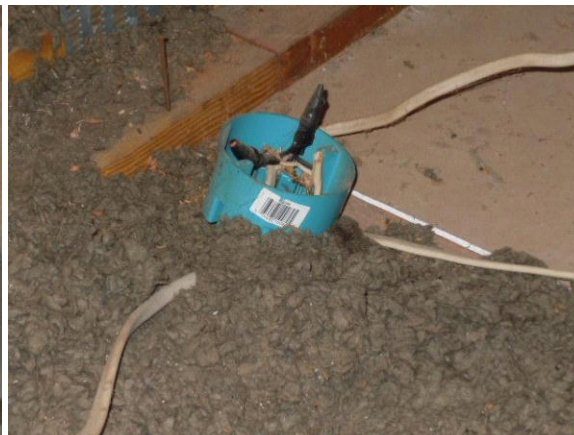
Open junction box

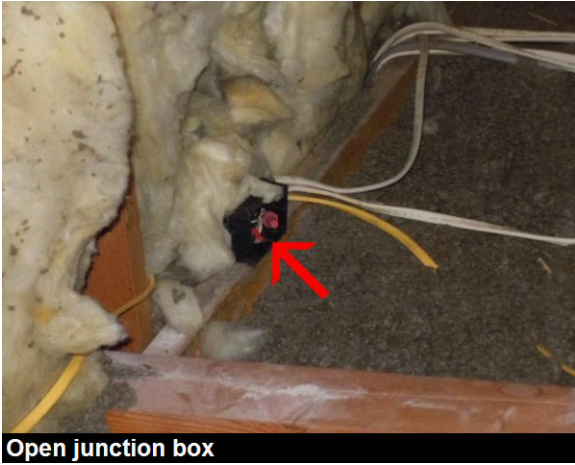
Open junction box

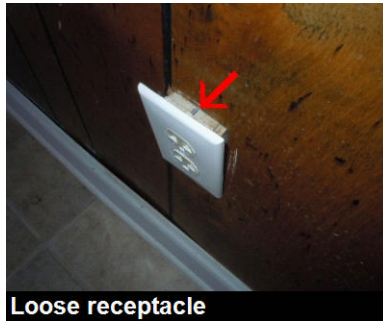
Loose receptacle

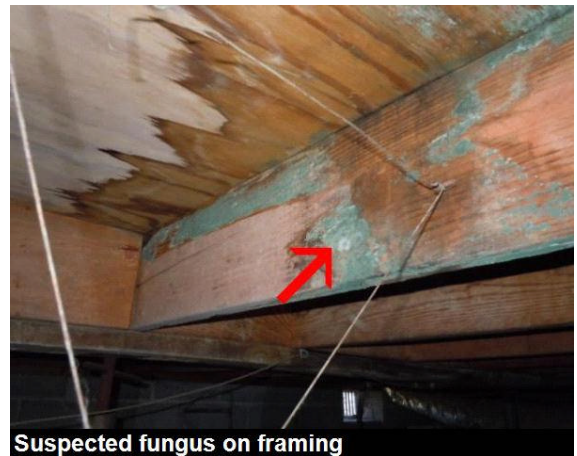
Suspected fungus on framing

There is some suspected fungus growth on the floor framing in the crawl space. If the purchaser has any concerns about mold additional testing by a certified mold technician is recommended.

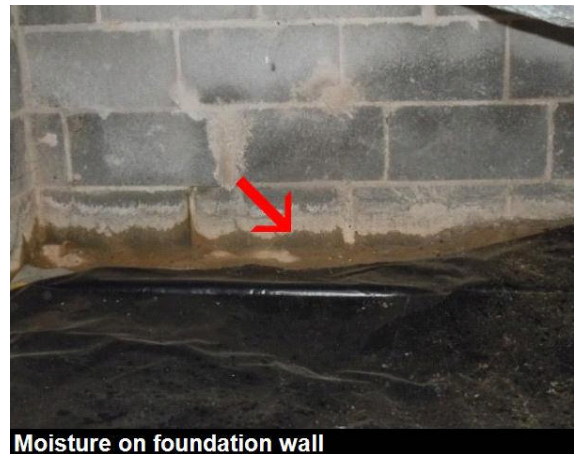
Moisture on foundation wall

There is water staining on the right front foundation wall indicating some water entry into the crawl space. Further evaluation of this condition by a qualified water proofing contractor is recommended.

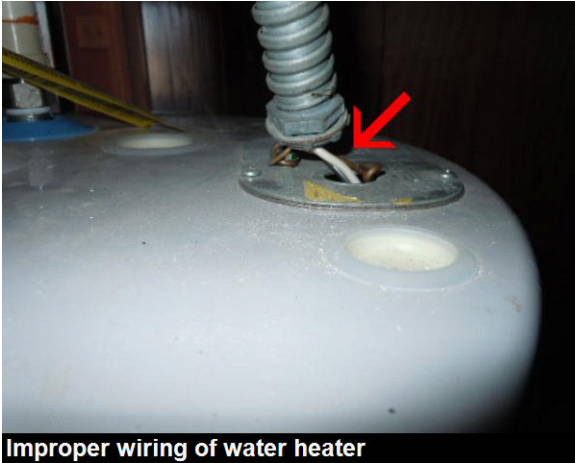
Improper wiring of water heater

The wiring is improperly attached to the top of the water heater.

Repairs should be made by a qualified, licensed plumber.

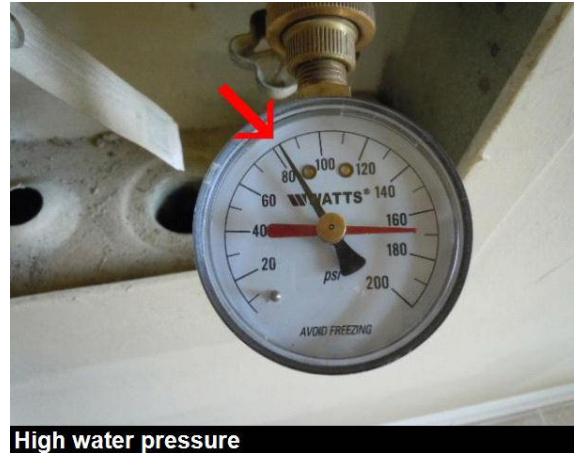
High water pressure

The house water pressure is higher than the maximum allowable 80 psi. Recommended water pressure should be between 40 and 80 psi. Due to the excessively high water pressure we recommend the installation of a PRV (pressure reducing valve) by a qualified, licensed plumber.

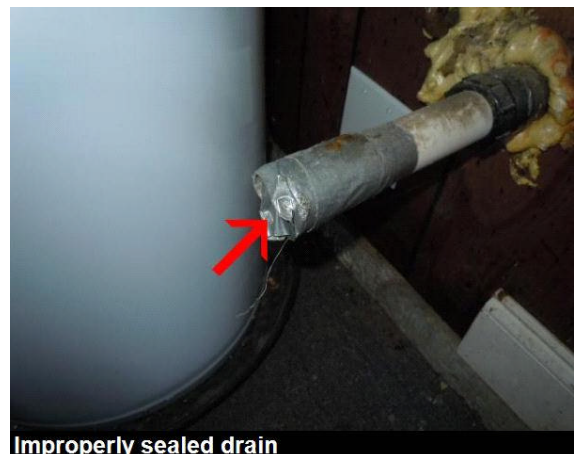
Improperly sealed drain

The drain pipe for a sink in the finished garage area has been improperly sealed with duct tape. Further evaluation and repair by a qualified, licensed plumber is recommended.

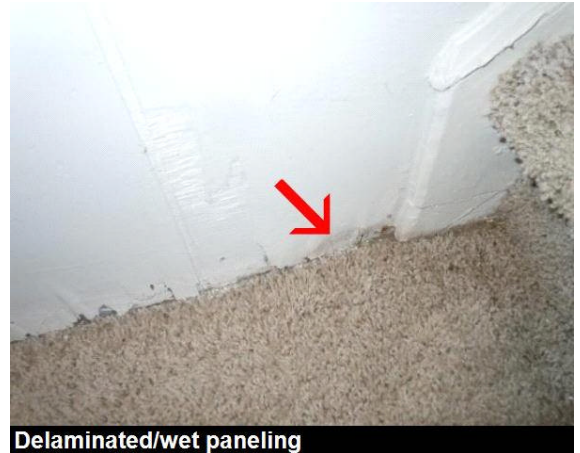
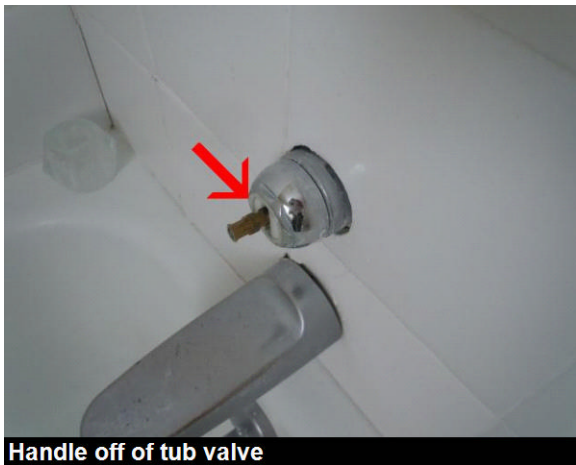
There is some delamination of the wall paneling in the hall outside the lower level shower. The delaminated area tested wet with a moisture meter indicating leaking from the shower pan adjacent to this wall.

Conditions should be further evaluated and repaired as necessary by a qualified, licensed plumber.

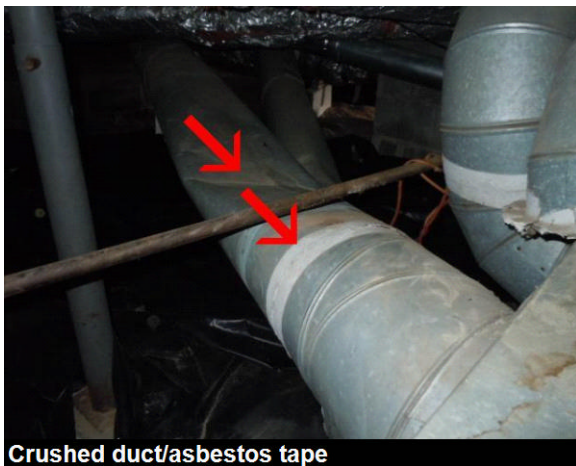
There is a partially crushed duct to the front of the furnace.

There is asbestos type tape installed on the ductwork joints

Crushed duct/asbestos tape

Repairs should be made by a qualified, licensed HVAC contractor.

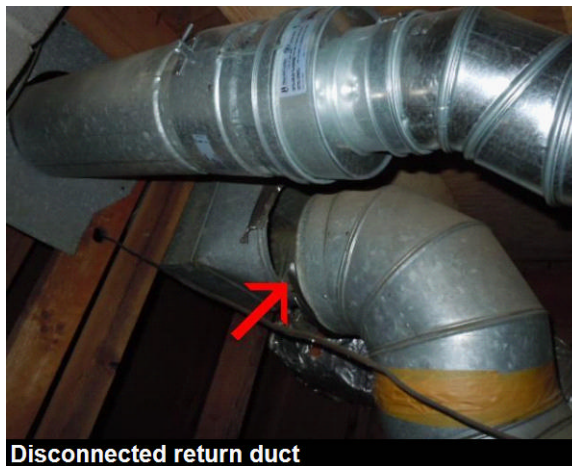
A return duct is disconnected in the left side of the crawl space.

Disconnected return duct

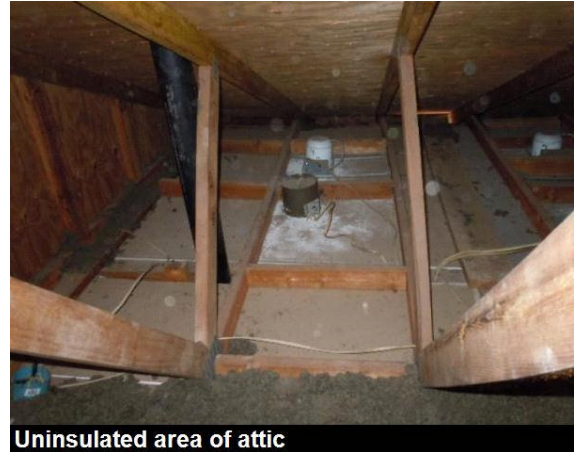
Uninsulated area of attic

The area over the bathrooms is not insulated. Installation of insulation to current standards is recommended.

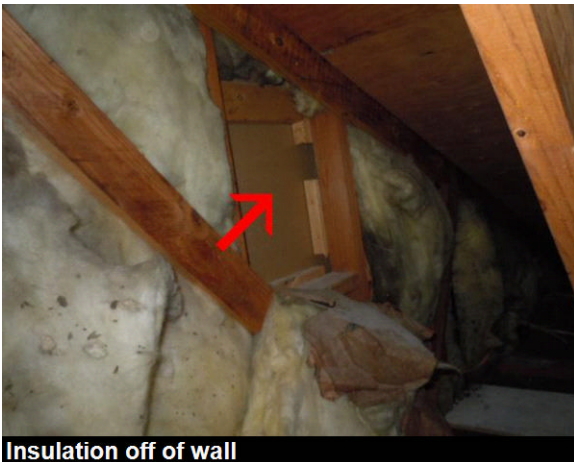
Insulation off of wall

Some insulation has fallen off of the left wall in the lower attic. the insulation should be replaced.

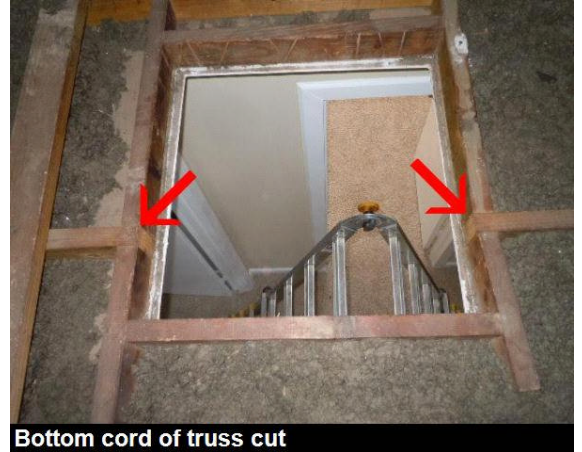
The bottom cord of a truss has been cut for the upper attic scuttle hole. This condition compromises the structural integrity of the truss. Further evaluation by a qualified, registered engineer is recommended.

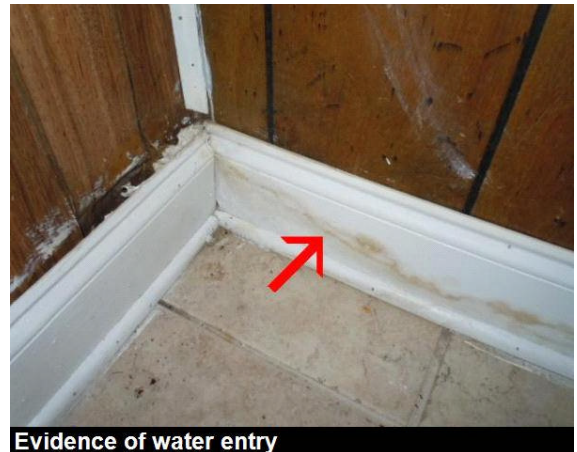
Water staining on the base molding in the front of the finished garage indicates water entry. Repair of this condition to prevent water entry by a licensed general contractor is recommended.
