Inspection Report

Property Address:
1884 Valley View Rd.
Snellville, GA 30078

Date:
November 20, 2012

Inspector:
Bill Garwood
Edifice Inspections, Inc.
(770) 594-2222
www.edificeinspections.com

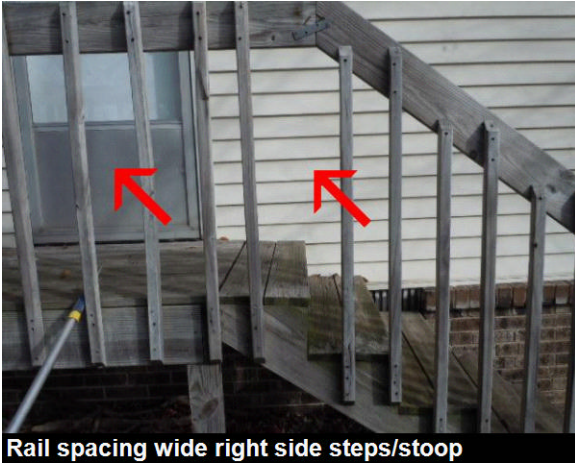
Condition: The spacing of the guardrails are wider than allowable by contemporary standards. Recommend repairs be made by a licensed general contractor for safety.
The right side wood stoop is not flashed at its connection to the house. This condition has resulted in decay of the original wood siding under the stoop. The decayed siding should be replaced and the stoop flashed by a licensed general contractor.

Decayed siding under stoop

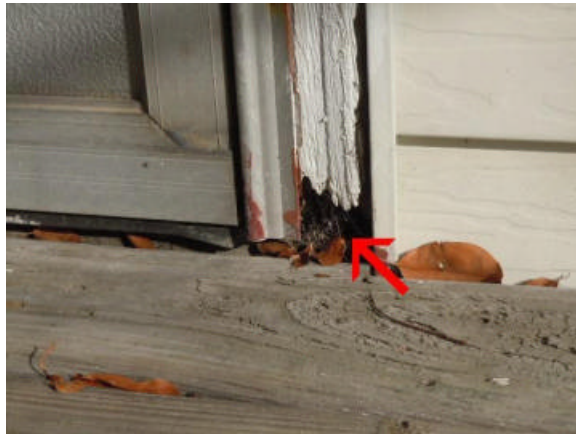
Condition: A piece of rake molding has warped at the rear upper gable. The bottom of the brick molding is decayed on the right side door. Conditions should be repaired/replaced as necessary by a licensed general contractor.

Warped rake molding
